## **Geophysical Surveys for Detecting Anomalous Conditions, Algiers Canal Levees, New Orleans, Louisiana**

José L. Llopis and Joseph B. Dunbar

August 2014

Final report

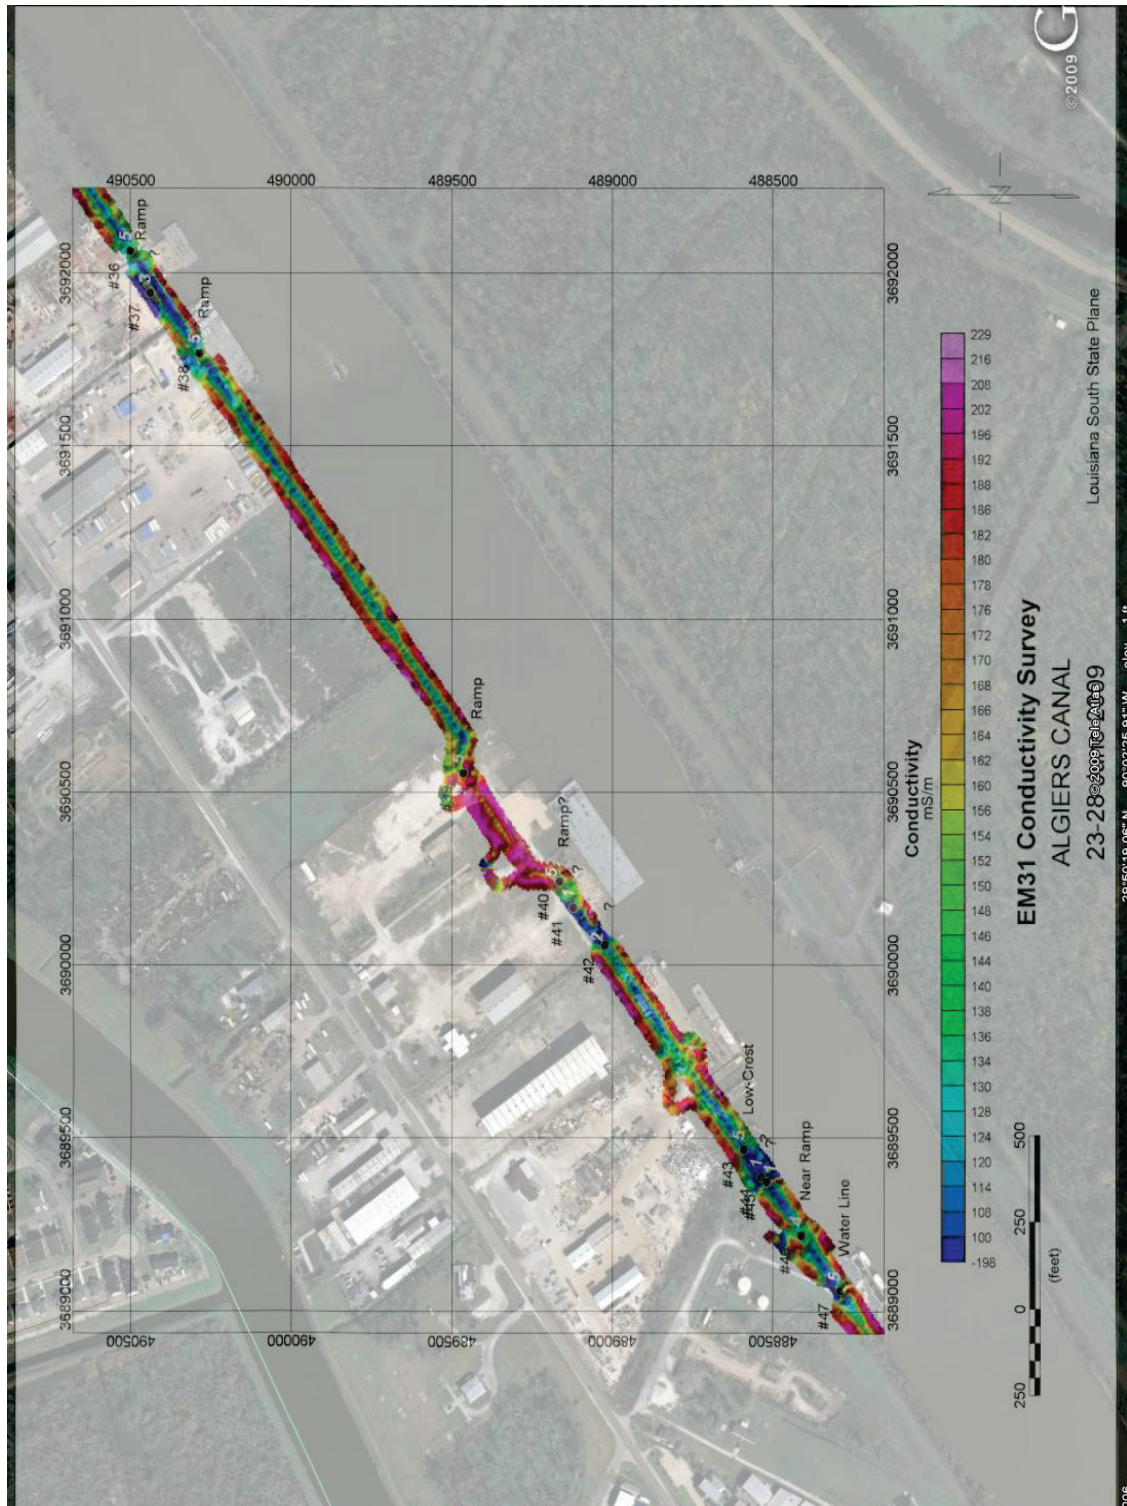
Figure 17. EM31 conductivity survey results overlaid on Google Earth image, Section 5.

This section stretches between approximate stations 1116+53 and 1154+48 and has three priority 1 and one priority 2 anomalies as shown in Figure 17. The priority 1 anomaly located at station 1141+03, anomaly 41, indicates the possibility of an object crossing beneath the levee. Anomaly 42, a priority 2 anomaly, indicates an area of low conductivity values in the center line of the levee near station 1142+39. Anomaly 41 may be caused by a change in material type. Anomalies 44 and 45 (stations 1150+70 and 1150+86, respectively) are located approximately 25 ft southwest of an area marked with cable crossing signs. These are two priority 1 anomalies and are probably caused by the same item. No indications of a buried cable were noted over the marked area, which is also characterized by a noticeable hump in the levee. However, approximately 20 to 30 ft southwest of the marked cable crossing area, the instrument indicated a strong response to a buried metallic object oriented perpendicular to the axis of the levee. Anomaly 47, located near station 1154+79, is caused by a buried steel pipe that crosses the levee and is visible on the protected toe. However, it is not nearly as strong as an anomaly shown in the in-phase results.

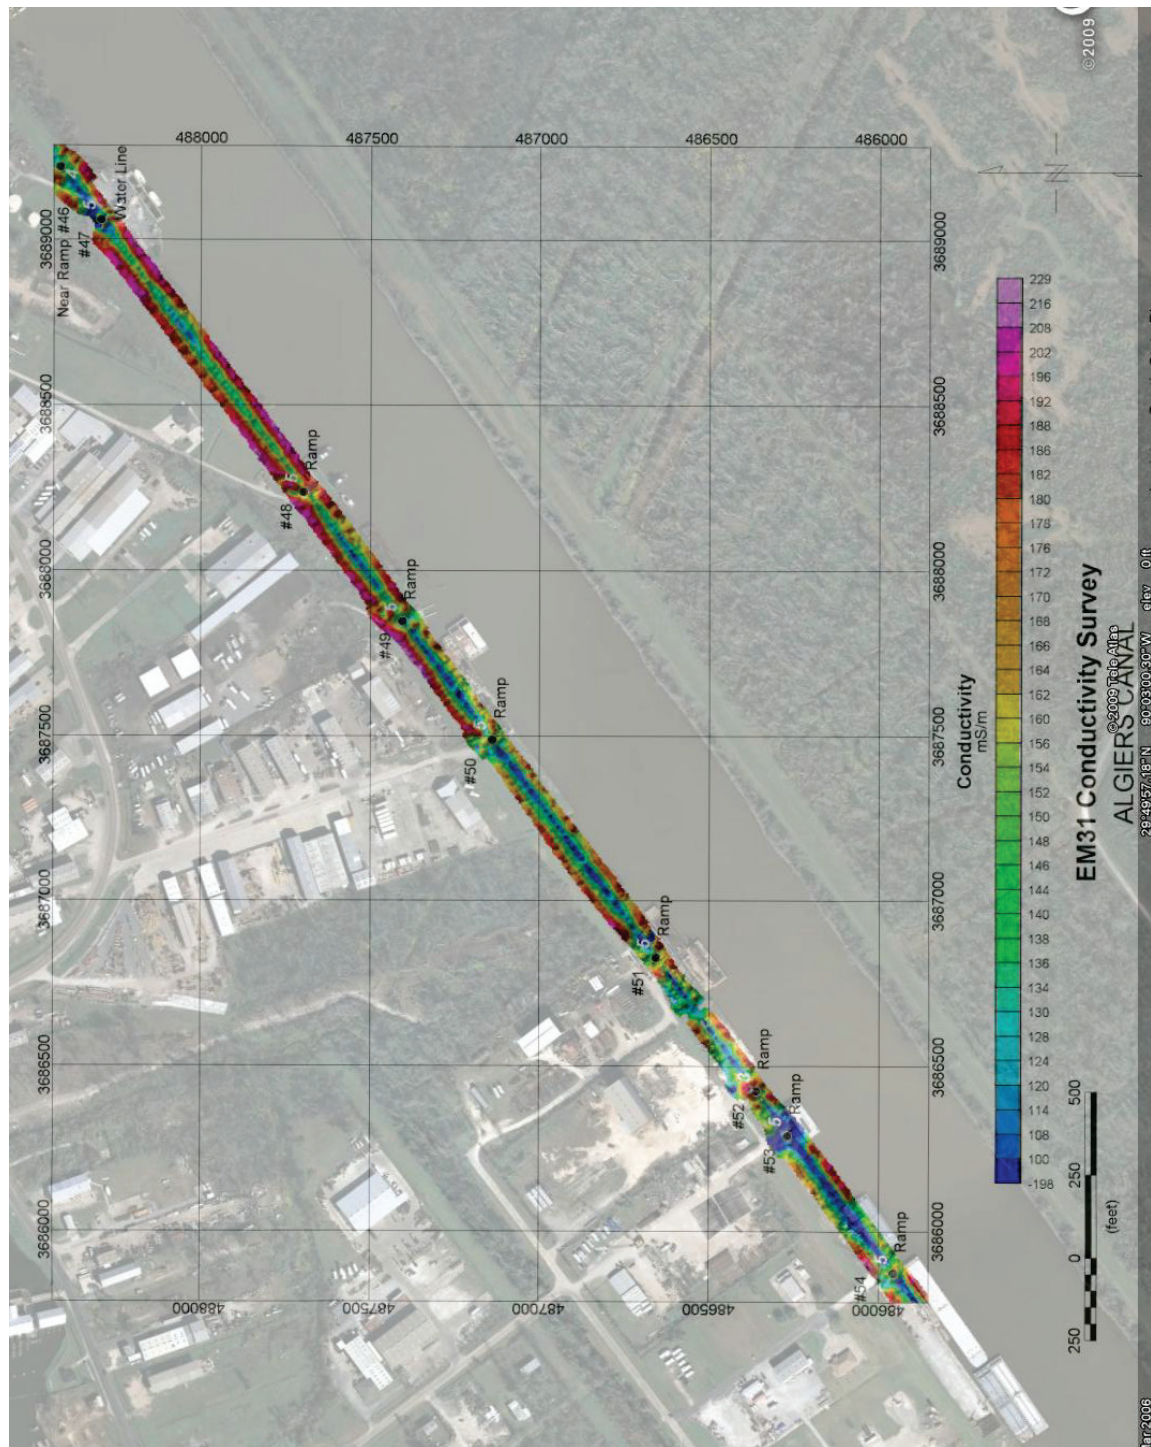
Figure 18. EM31 conductivity survey results overlaid on Google Earth image, Section 6.

This section stretches between approximate stations 1154+48 and 1194+31 (Figure 18). All of the anomalies in this section have priority numbers of 5, with the exception of anomaly 52 that has a priority of 3. The location of anomaly 52, station 1187+50, coincides with the location of a ramp. However, there is an indication of a localized metallic object.

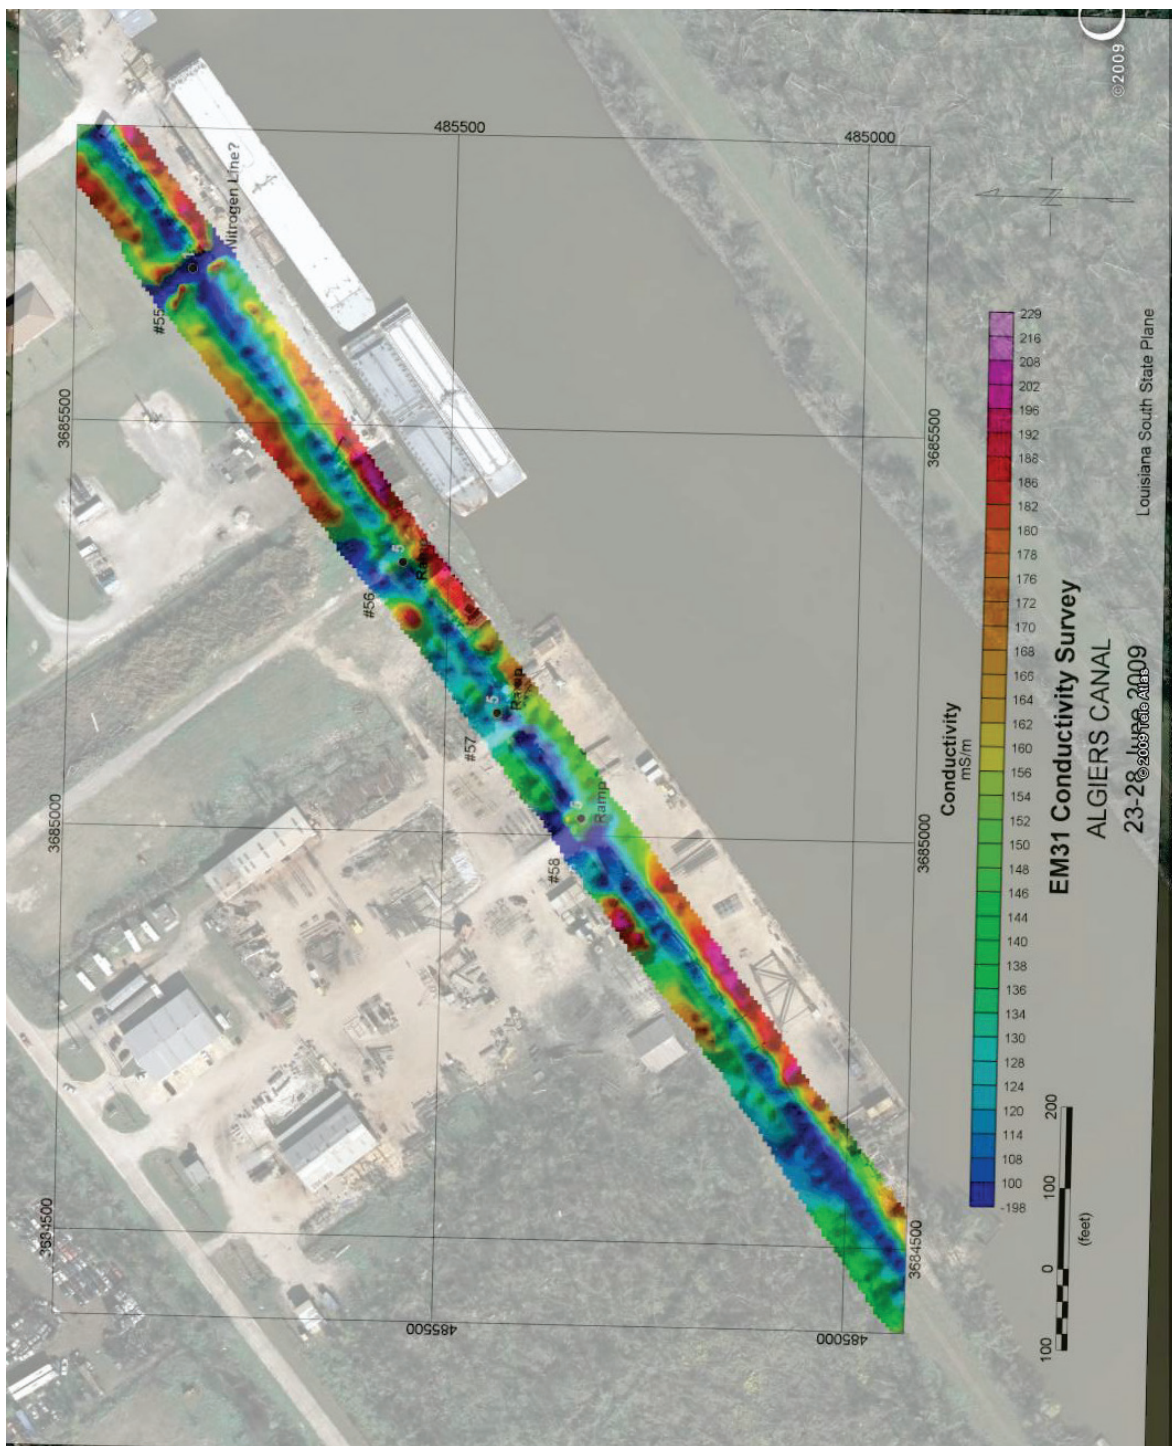
Figure 19. EM31 conductivity survey results overlaid on Google Earth image, Section 7.

Section 7 extends between approximate stations 1194+31 and 1211+26 (Figure 19). Four anomalies, one a priority 1 and the remaining three priority 5 anomalies, were interpreted for this section. Anomaly 55, a priority 1 anomaly, is located at station 1196+63, and is a strong linear-shaped anomaly that crosses the levee. There is a hump in the levee center line directly over the location of the anomaly. It is presumed that this anomaly is caused by a buried nitrogen line indicated in the construction drawings. The remaining anomalies coincide with the locations of ramps.

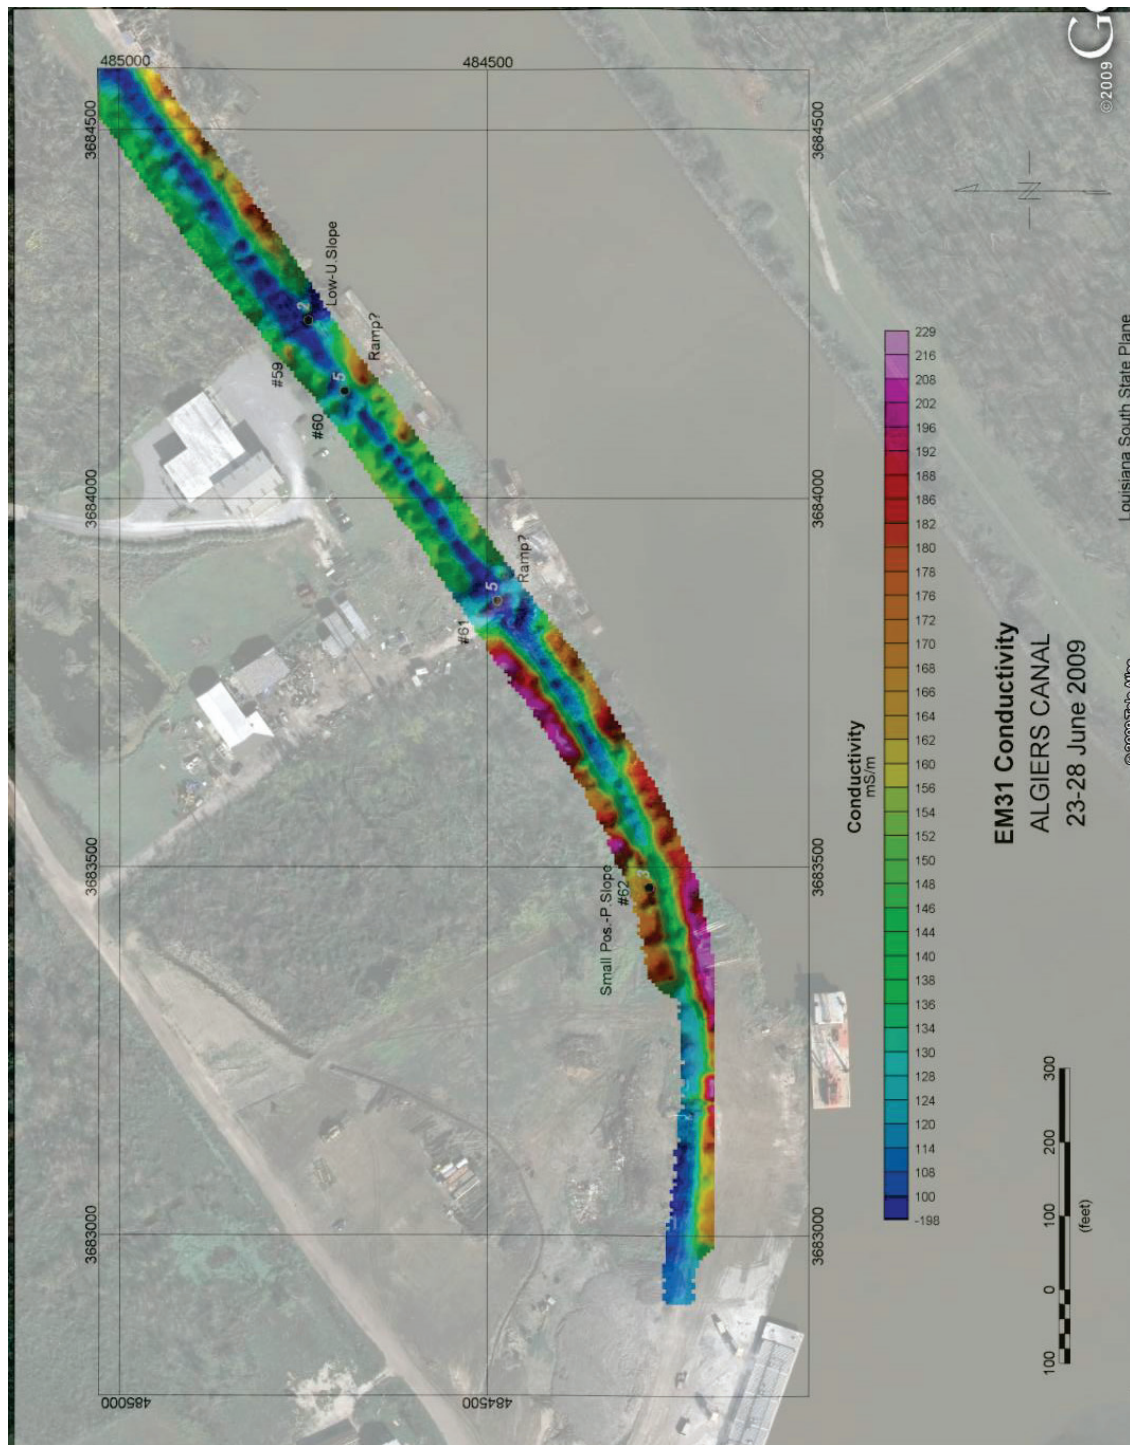
Figure 20. EM31 conductivity survey results overlaid on Google Earth image, Section 8.

The southernmost section extends between approximate stations 1211+76 and 1229+44 (Figure 20). Anomaly 59, a priority 2 anomaly, indicates the possibility of an object on or below the unprotected slope or a change in material. This section of levee had not been raised at the time this survey was conducted.
